— HOW TO ADJUST —

LWZ-1 ZONE LOCKING DEVICE NEW INSTALLATION	
				SCALE 1/4	DATE 5-31-94
				DWG. BY	M7410
No.	REVISION	DATE	CHK.	CHK. BY

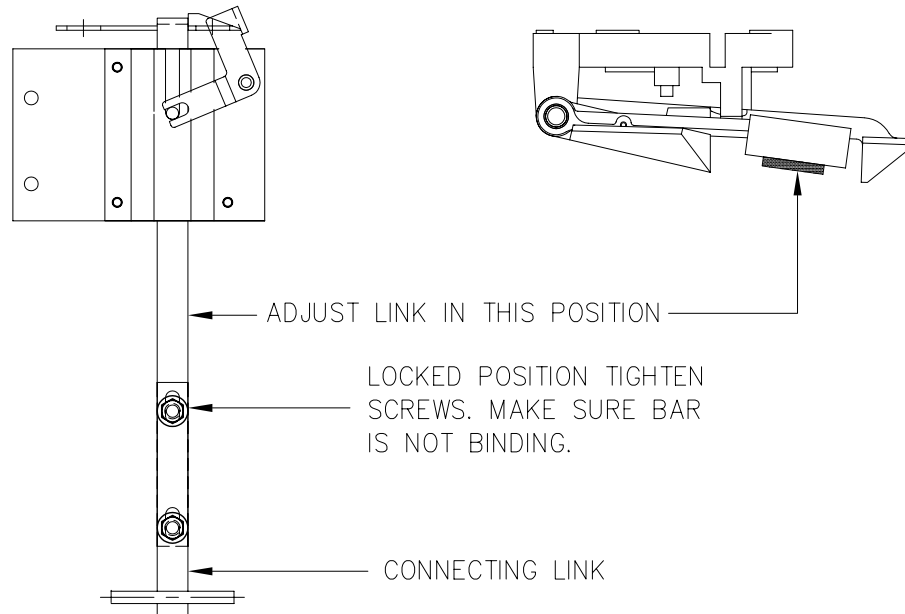
①

CAR DOOR LOCKED  
NO INTERLOCK ROLLERS PRESENT

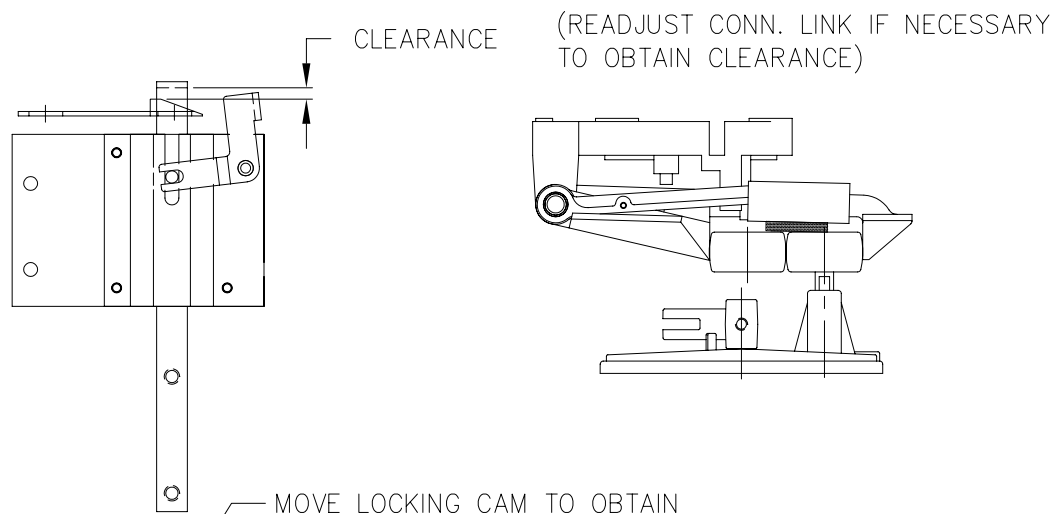
②

DOORS PARTIALLY OPENED  
SENSING BAR RESTING  
ON INTERLOCK ROLLERS
